# Minimox®

## Reduction Of Carburization of 330 Stainless Steel With Minimox® Self-Protective Alloy Treatment

Technical  
Bulletin

Carburization  
Reduction  
330 Stainless  
Steel

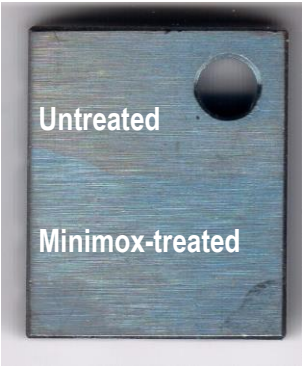
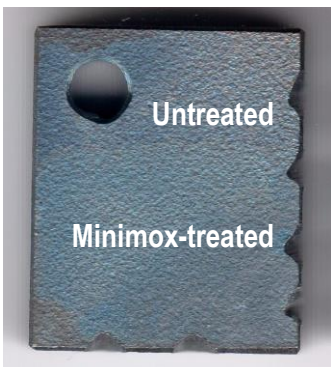
Machined surfaces ↓

Mill-finish surfaces ↓

Figures 1a, 1b. Bottom half of each of these coupons is Minimox treated. Coupons were oxidized at 600°C, 10 hrs.	Figures 2a, 2b. Partially Minimox-treated & oxidized coupons after carburization test.	Figures 3a, 3b. 330 stainless after carburization, without Minimox or oxidation.
<b>When Figure 2 is compared to Figure 3, Minimox treatment and oxidation significantly reduces carbon uptake.</b>

One side of the test coupons were machined to a 220 finish while the second side remained the mill finish Figure 1 shows the partially treated coupon after oxidation. Figure 2 shows a parallel sample after the pack carburization testing. For comparison, Figure 3 shows an untreated/unoxidized sample after carburization.
